# Holding Pond Annual Inspection Report

Marquette Board of Light and Power  
Shiras Steam Plant

Project Number: 60445171

January 12, 2018

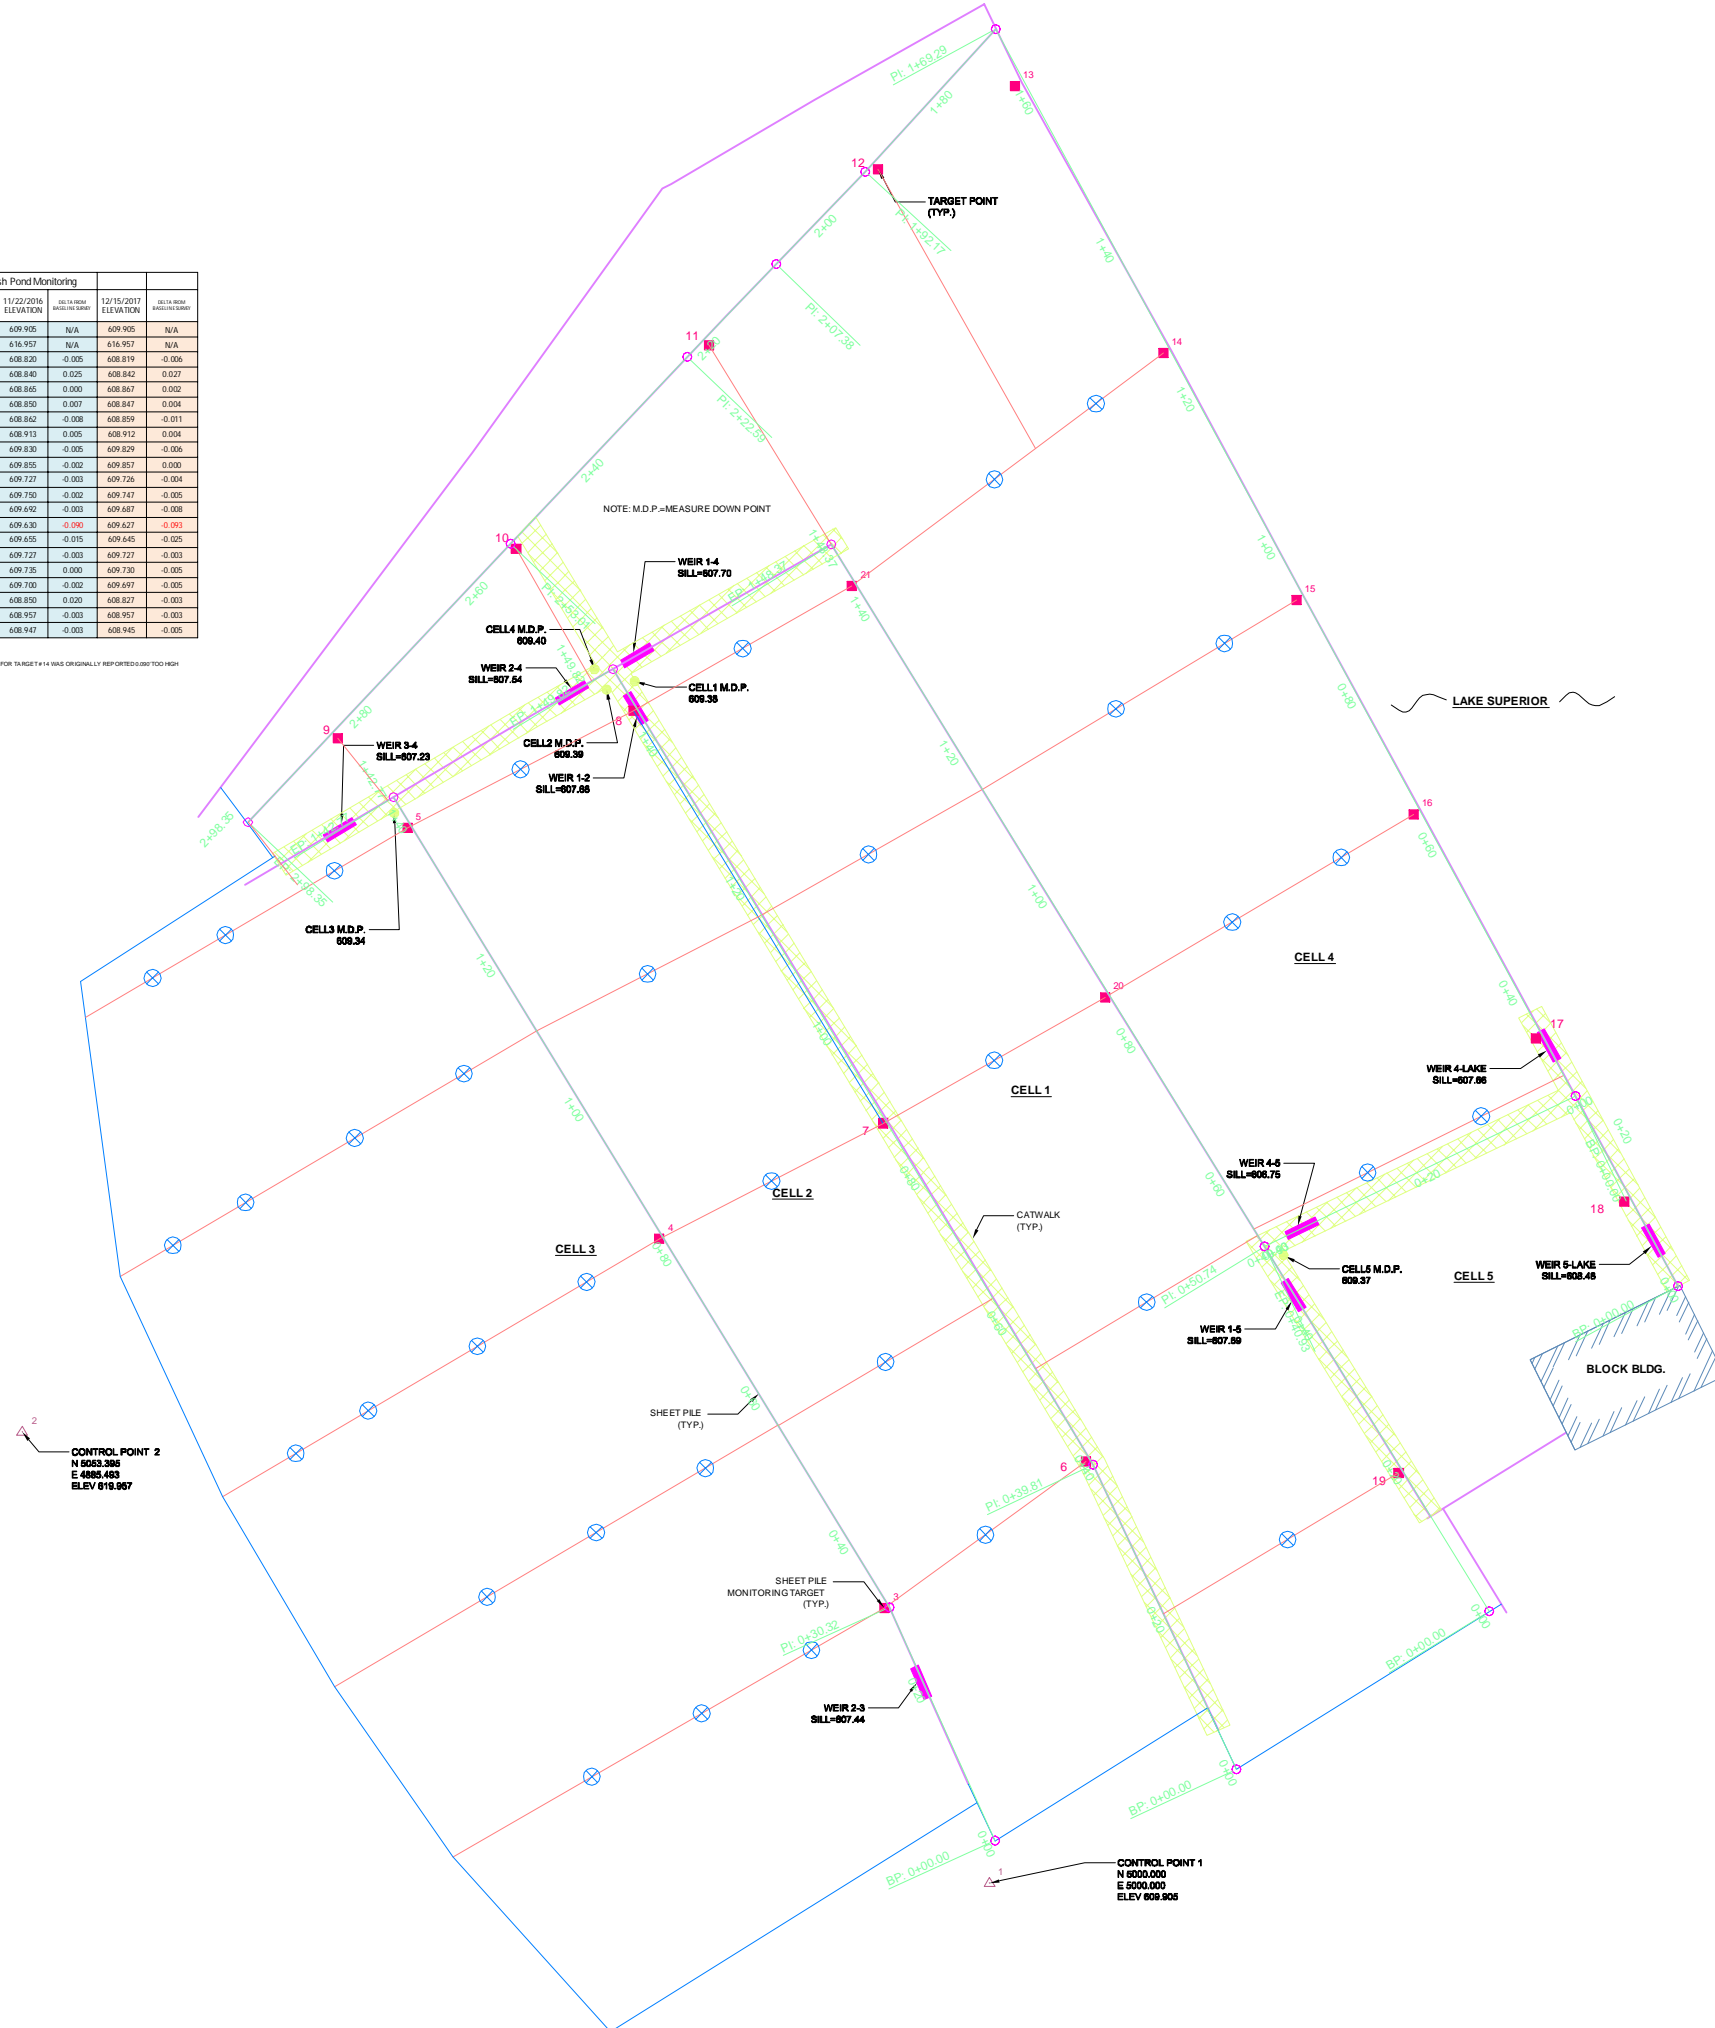
**G-01**

Movement monitoring targets were also installed during the October 15, 2015 survey work. These reflectorized targets were installed near the top of the sheet pile walls at the locations shown on Drawing 1 in Appendix A. Initial coordinates of each target were determined using a total station laser survey instrument set-up over 2 control points which were established on the south and west shores of the pond. The current coordinates of the targets were checked by an AECOM survey crew on December 15, 2017. The majority of the sheet pile walls showed no significant lateral movement or settlement. This is a good indication that the sheet pile walls are generally stable.

Targets 6 and 7 showed a small but detectable amount a lateral movement. These targets are located on the interior sheet pile wall between cells 1 and 2. Although the lateral movement is relatively small (1.2" maximum), it is about two times the movement which was detected in our previous annual report. This indicates the wall may be slowly starting to shift laterally. This is viewed as a minor finding since the movement is small, the interior walls are not critical for containment of the CCR residuals, and the perimeter sheet pile containment walls do not show any signs of significant movement. Although the sheetpile wall is in poor condition, the lateral movement is not visually apparent and there does not appear to be any distress to the walkway mounted on top of the wall. We suggest continued monitoring of the points during subsequent annual inspections.

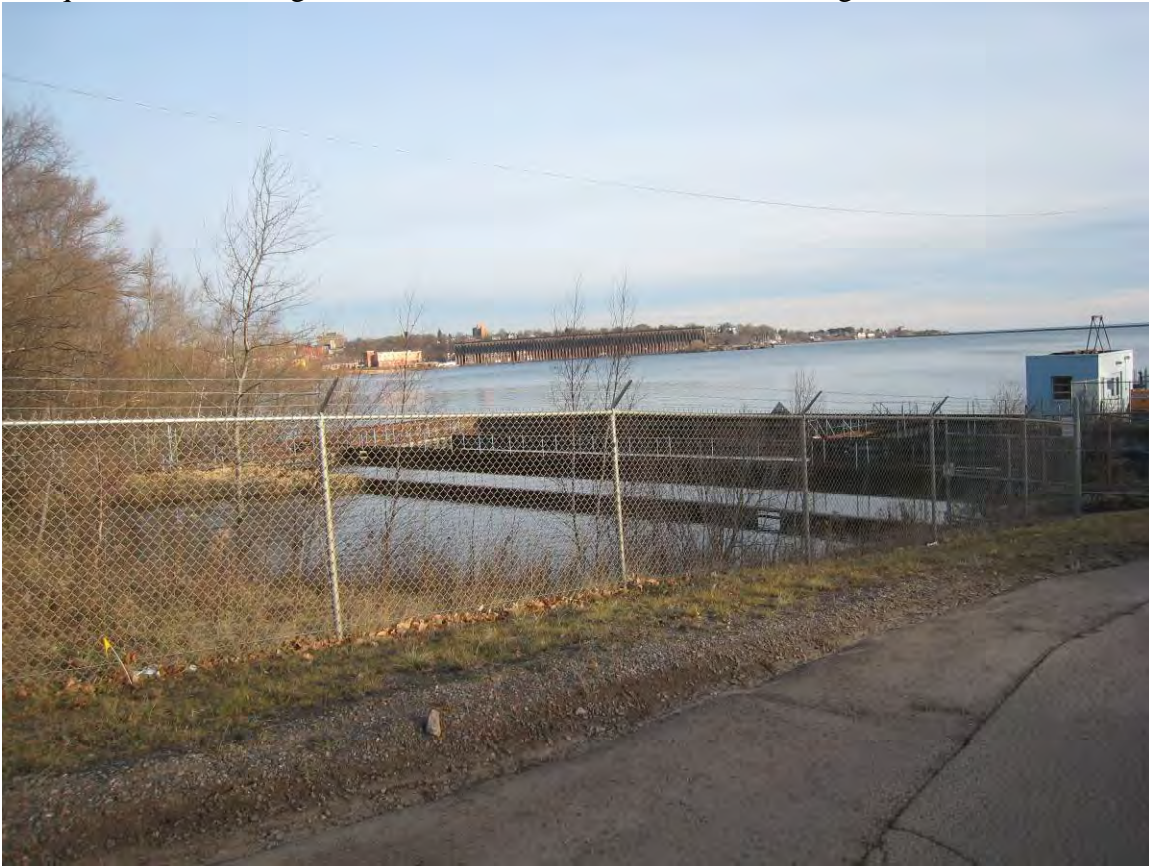
Photo1- Holding Pond

The holding pond is composed of 5 cells which are enclosed by steel sheet pile walls. Its overall configuration is shown in Drawing 1 in Appendix A, and an overall view is shown in Photo 1 in Appendix C. It has been expanded and modified a number of times since constructed. The south and west boundaries of the holding pond are formed by the shoreline of the lake. The east and north boundaries of the holding pond are formed by sheet pile walls which were constructed in 1981. Because of the poor condition of the original north wall, an additional wall was constructed to replace it in 2013. The new wall was placed inside of the original existing north wall, which remains but no longer provides containment (Photo 3 in Appendix C). The walls for the inner cells 1, 2, and 3 were constructed in 1990. There are also some abandoned sheet pile walls in place from previous configurations. The last change to the pond configuration was the addition of the north sheet pile wall in 2013 mentioned above.

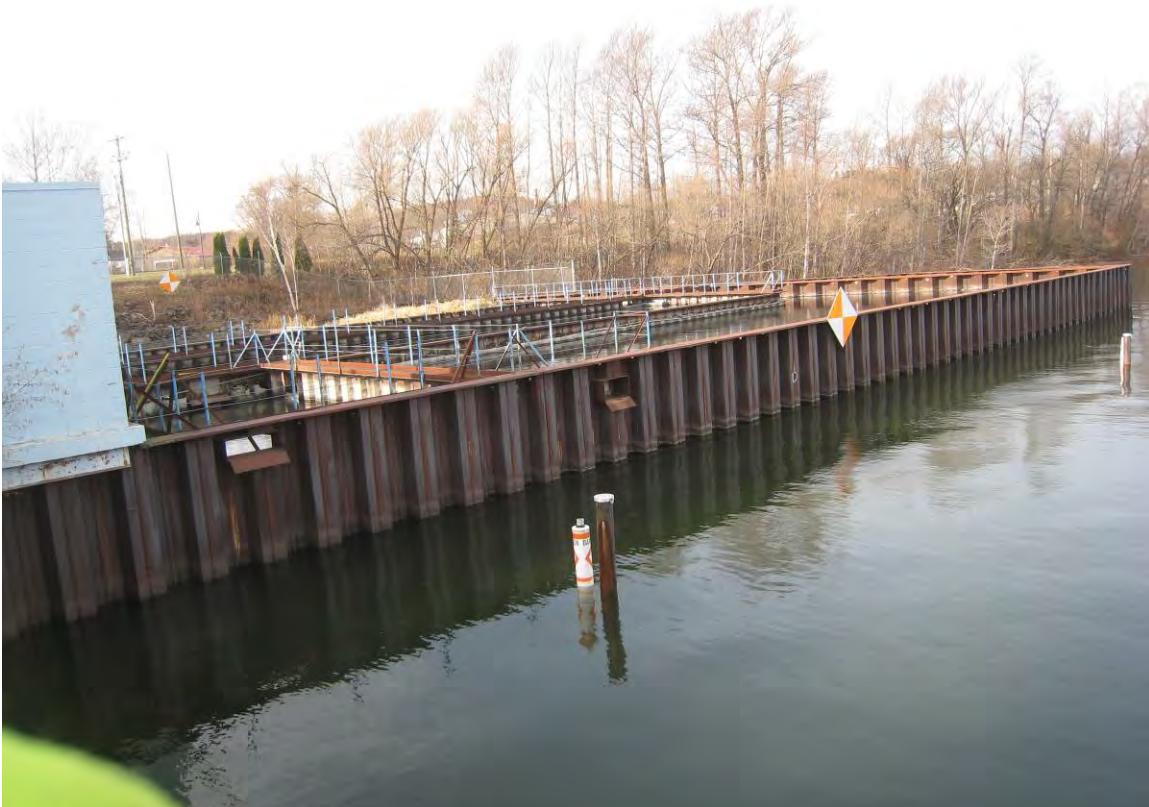
Photo 2 – Overall View of East Wall

The steel surface on the Lake Superior side of the east sheet pile was bare and the majority of the wall appeared to be in good condition (Photo 2 in Appendix C). The north wall is newer and in very good condition. There were a number of spots of localized corrosion which occurred primarily at the joints between the sheets (Photos 4 and 5 in Appendix C). Most of these had an appearance that suggested there may have been seepage through the joint at one time. No seepage was evident during this evaluation.

During our initial annual inspection performed in November of 2015, thickness measurements were taken in order to get an overall view of the condition of the wall. Generally speaking, the readings varied from 0.33-inches to 0.40-inches, indicating little to no loss of the original 3/8-inch steel thickness. There are small areas of more severe localized corrosion (Photo 5 in Appendix C). We would regard this amount of steel loss as non-critical, since they are small 2-inch to 3-inch wide areas and will not materially reduce the structural capacity of the wall. In addition, our structural analysis of the wall performed in 2013 showed that this exterior wall had a large margin of reserve strength and could tolerate over 50% loss of steel thickness due to corrosion.

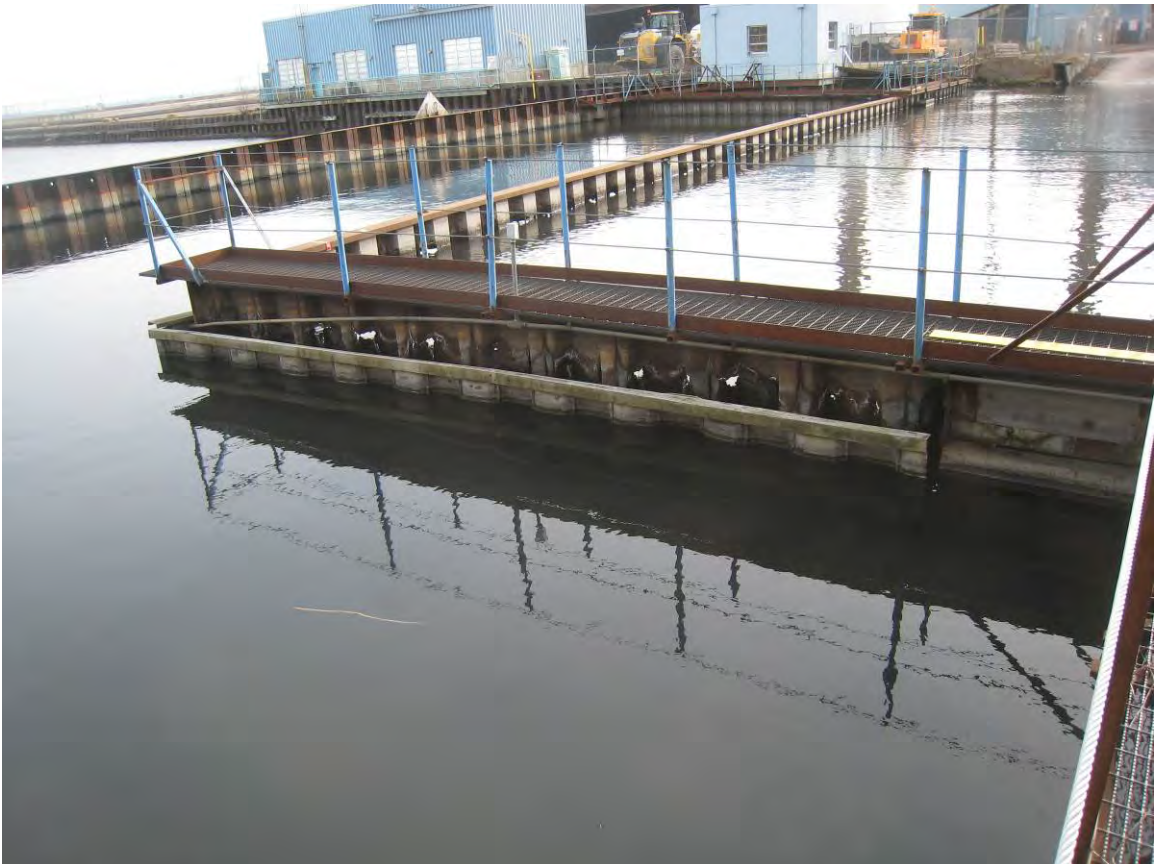
Photo 6 – Interior Walls in Poor Condition

The remaining sheet pile walls which form the internal boundaries between the cells are constructed of a lighter gage sheet pile. It was not possible to examine these walls closely because the cells were full of water and the walls were mostly submerged. The exposed portions appear to be in poor condition. These internal walls, however, do not affect to the structural ability of the pond to contain CCR ash and are only used as baffles to improve the settlement of ash out of the water. Some minor lateral movement was detected to the interior wall between cells 1 and 2. This is viewed as a non-critical for the reasons discussed above in section 2.2.

The south and west sides of the holding pond are incised into the ground and pose no threat of failure, resulting in a release of CCR materials. The east steel sheet pile wall of the holding pond is currently in fairly good condition and has a good reserve of structural bending capacity. A new heavy gage sheet pile wall was installed in 2013 to replace the deteriorated north wall of the holding pond and is in very good condition. The north and east sheet pile wall both appear to be stable and have ample structural capacity to contain the impounded water. The interior sheet pile walls are in poor condition, but are not required for containment integrity of the holding pond. The interior walls can continue to function in this condition as separators between the cells to improve the settlement of solids out of the process water.
