Holding Pond Annual Inspection Report

Marquette Board of Light and Power
Shiras Steam Plant

Project Number: 60445171

January 9, 2019

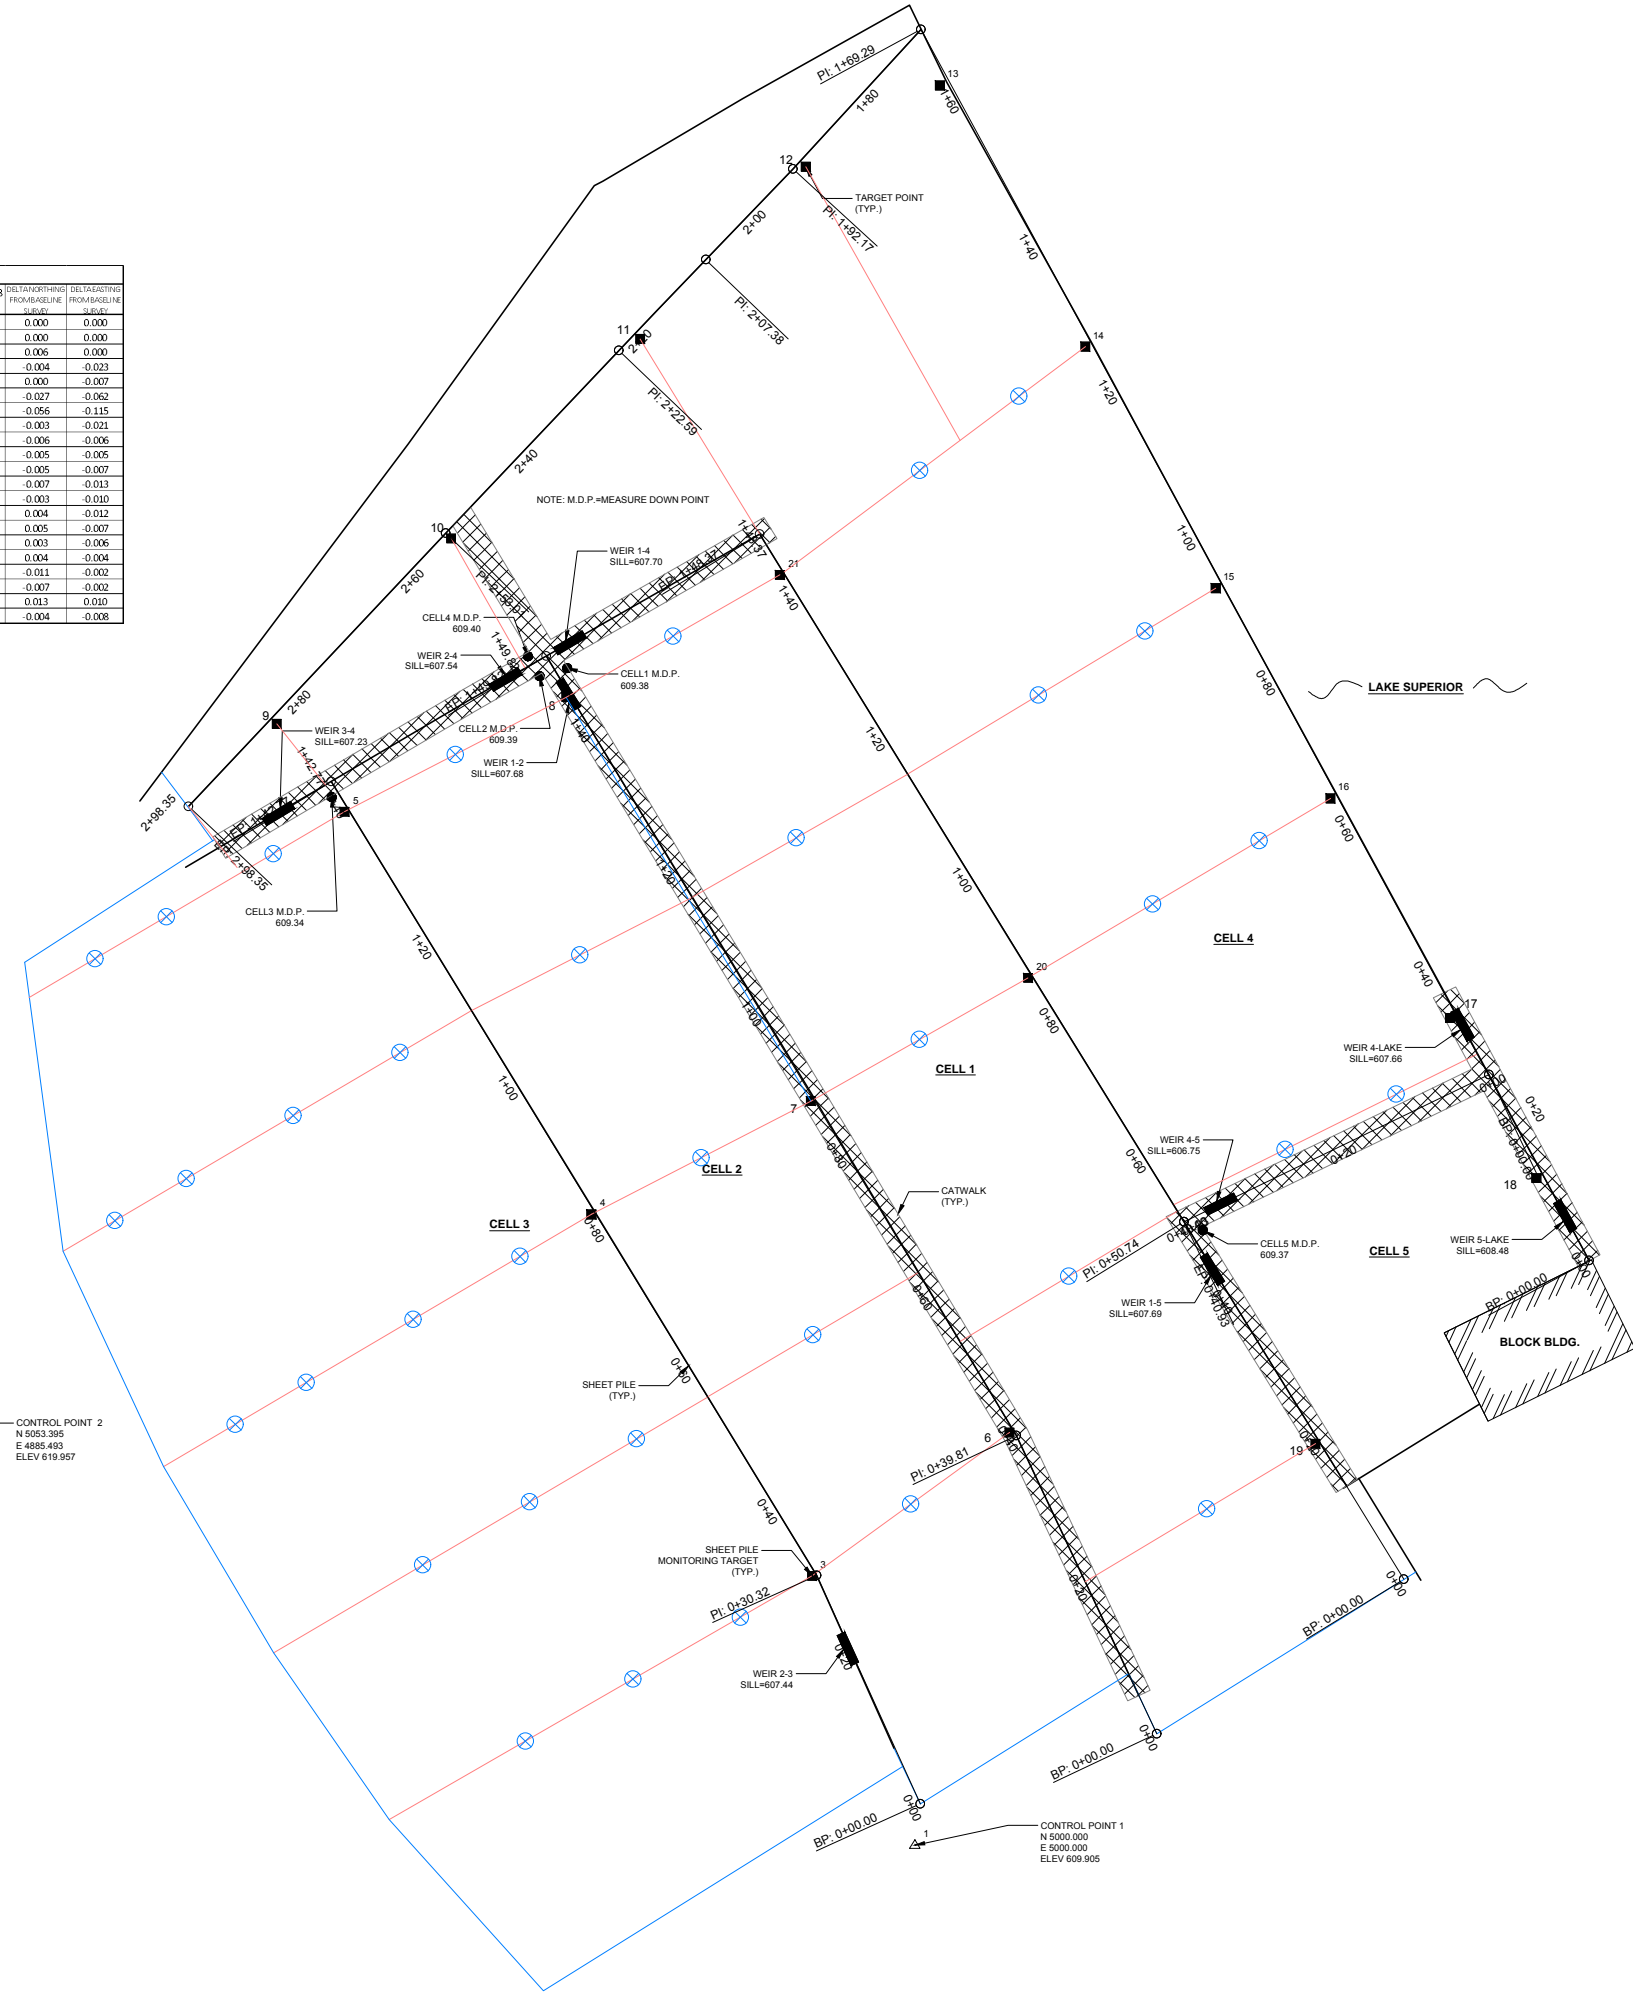
G-01

Movement monitoring targets were also installed during the October 15, 2015 survey work. These reflectorized targets were installed near the top of the sheet pile walls at the locations shown on Drawing 1 in Appendix A. Initial coordinates of each target were determined using a total station laser survey instrument set-up over 2 control points which were established on the south and west shores of the pond. The current coordinates of the targets were checked by an AECOM survey crew on November 16, 2018. The majority of the sheet pile walls showed no significant lateral movement or settlement. This is a good indication that the sheet pile walls are generally stable.

Targets 6 and 7 showed a small but detectable amount of lateral movement. These targets are located on the interior sheet pile wall between cells 1 and 2. The total lateral movement from the 2015 baseline survey is relatively small with a maximum value of 1.5 inches. In addition, the rate of change in the movement decreased from 0.47 inches/year in 2017 to 0.17 inches/year in 2018. This indicates the lateral shifting of the wall may be starting to stabilize.

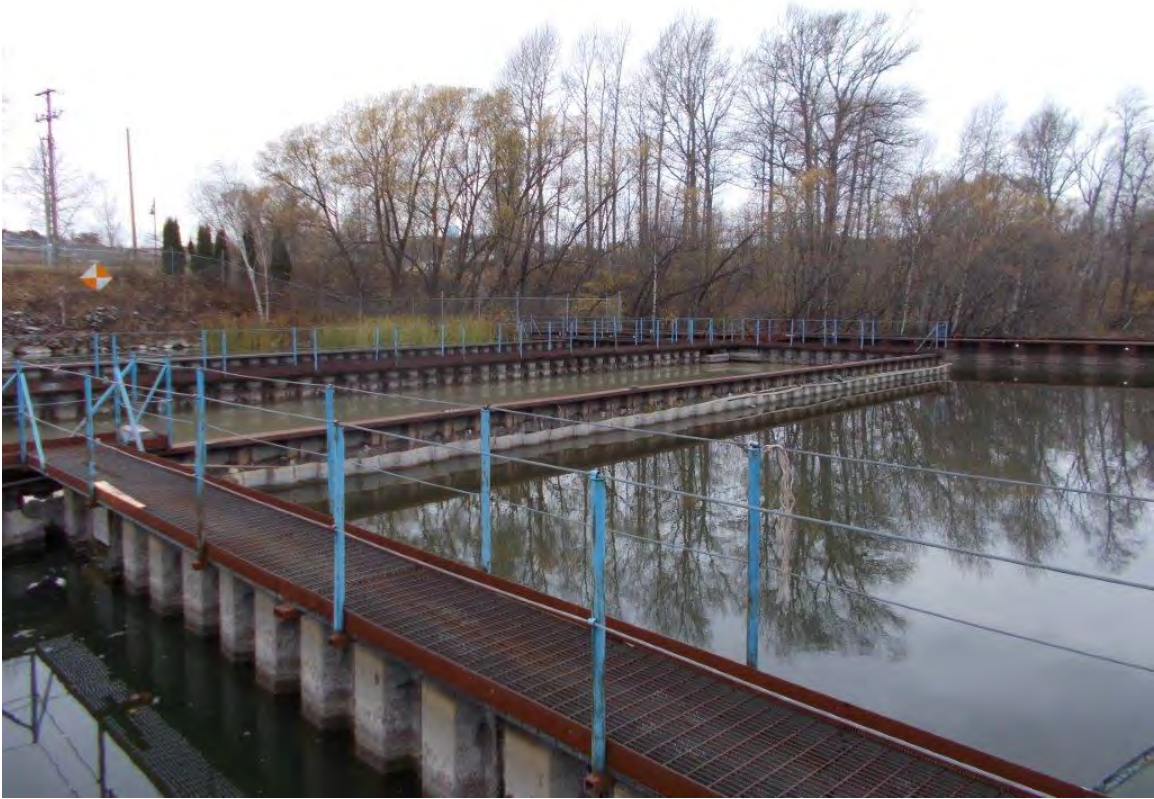
Photo1- Holding Pond

The holding pond is composed of 5 cells which are enclosed by steel sheet pile walls. Its overall configuration is shown in Drawing 1 in Appendix A, and an overall view is shown in Photo 1 in Appendix C. It has been expanded and modified a number of times since constructed. The south and west boundaries of the holding pond are formed by the shoreline of the lake. The east and north boundaries of the holding pond are formed by sheet pile walls which were constructed in 1981. Because of the poor condition of the original north wall, an additional wall was constructed to replace it in 2013. The new wall was placed inside of the original existing north wall, which remains but no longer provides containment (Photo 3 in Appendix C). The walls for the inner cells 1, 2, and 3 were constructed in 1990. There are also some abandoned sheet pile walls in place from previous configurations. The last change to the pond configuration was the addition of the north sheet pile wall in 2013 mentioned above.

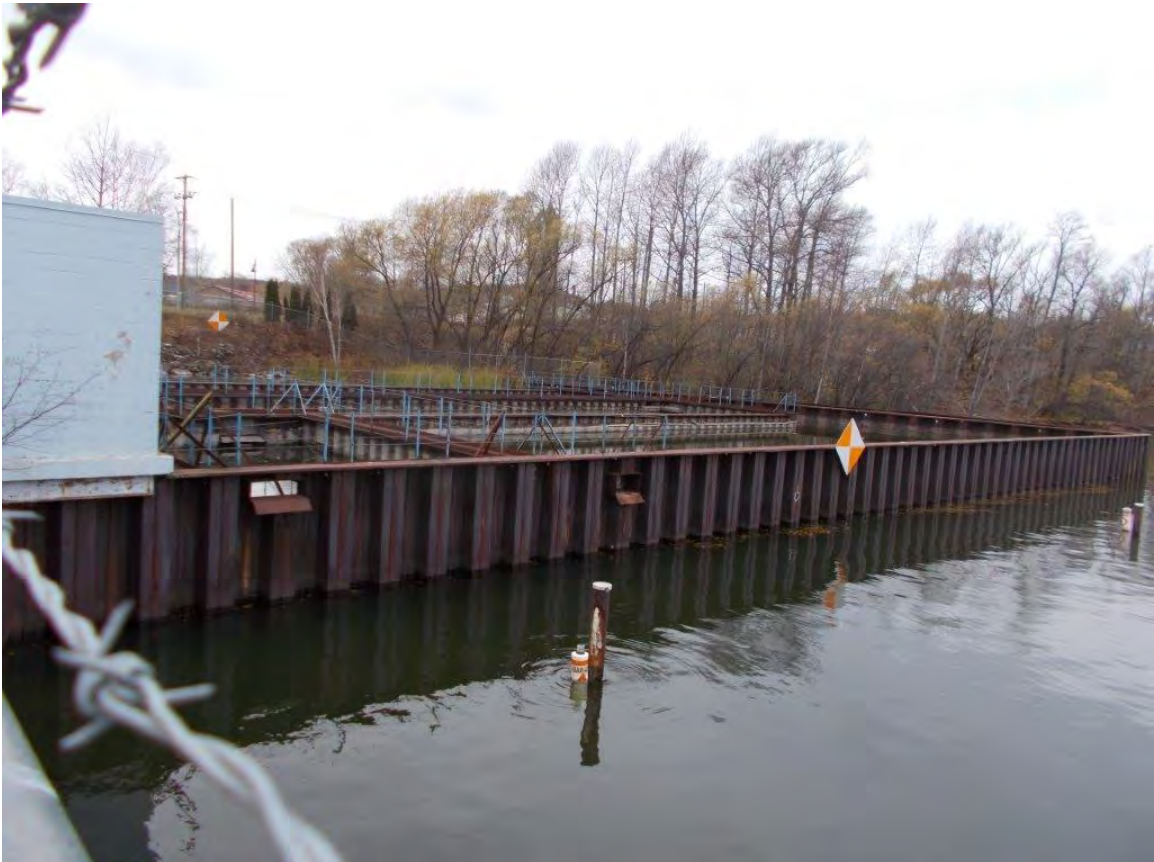
The steel surface on the Lake Superior side of the east sheet pile was bare and the majority of the wall appeared to be in good condition (Photo 2 in Appendix C). The north wall is newer and in very good condition. There were a number of spots of localized corrosion which occurred primarily at the joints between the sheets (Photo 4 in Appendix C). Most of these had an appearance that suggested there may have been seepage through the joint at one time. No seepage was evident during this evaluation.

Photo 2 – Overall View of East Wall

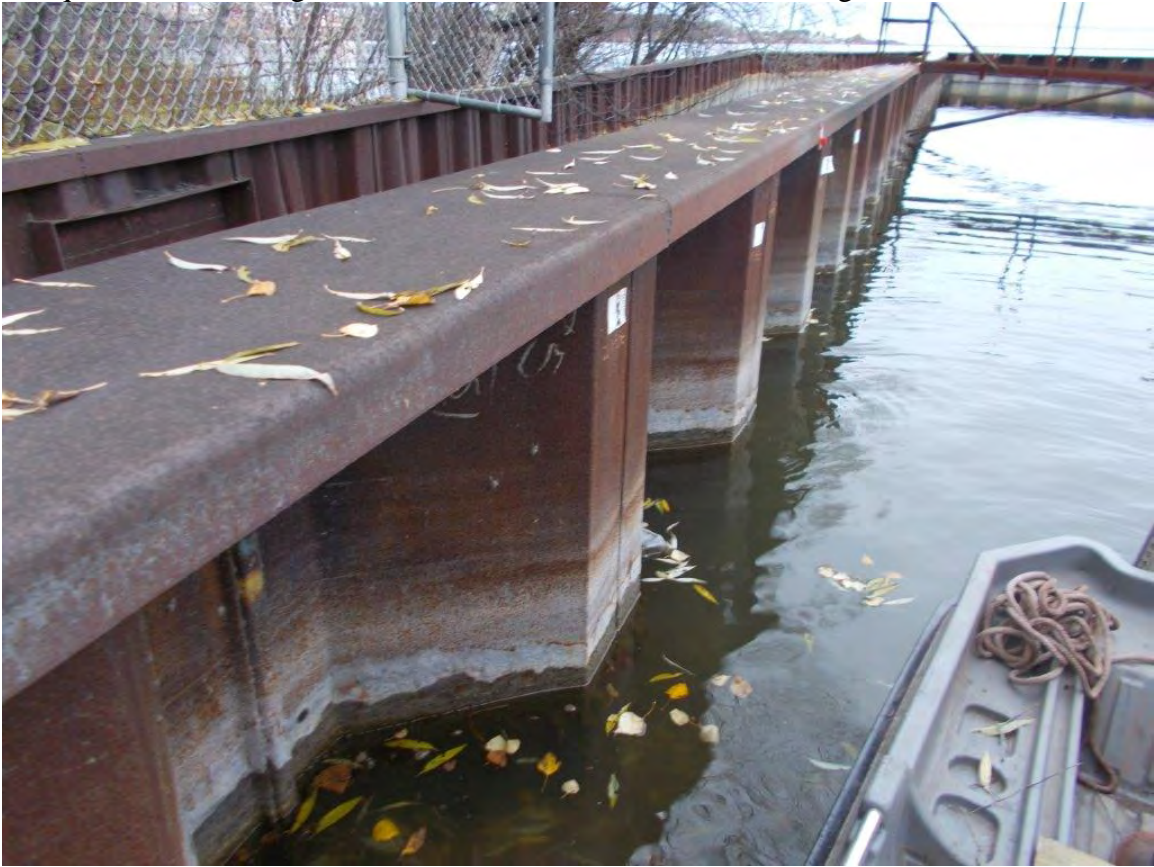
Photo 3 – Recently Constructed North Sheet Pile Wall

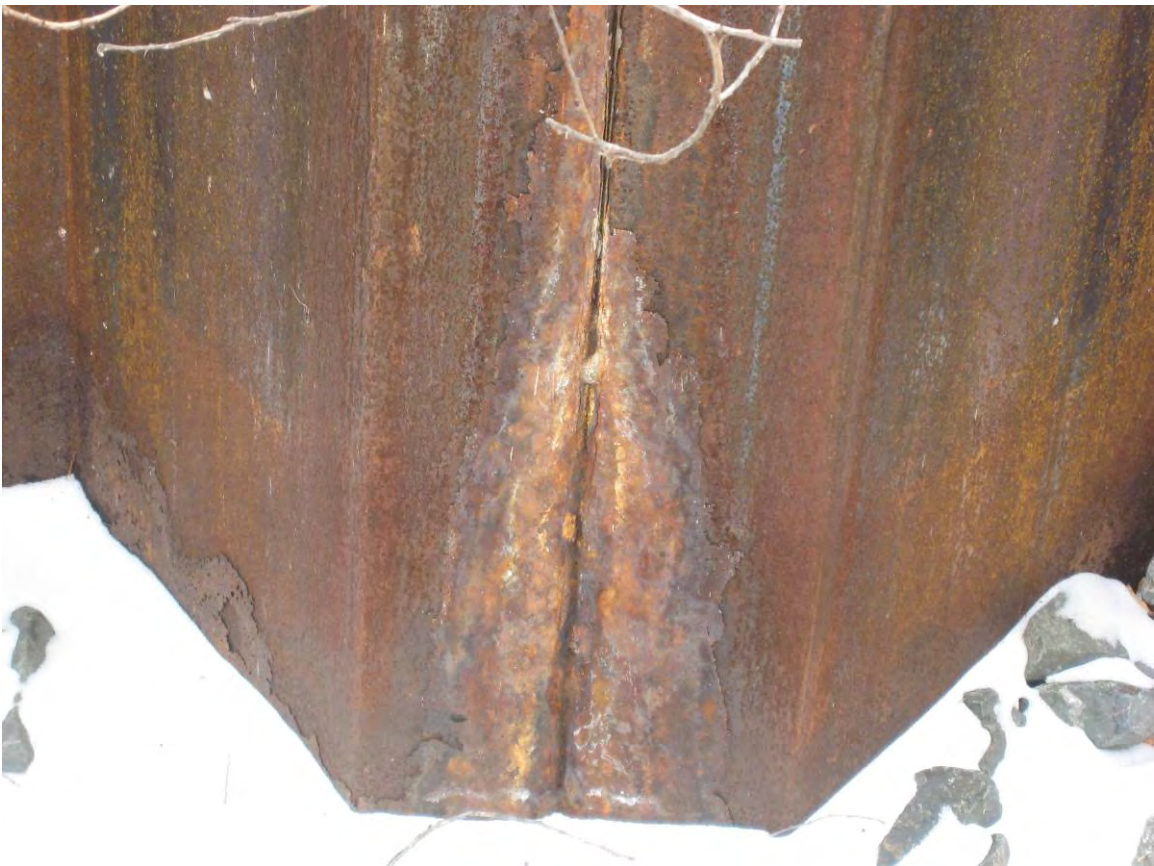
During our initial annual inspection performed in November of 2015, thickness measurements were taken in order to get an overall view of the condition of the wall. Generally speaking, the readings varied from 0.33-inches to 0.40-inches, indicating little to no loss of the original 3/8-inch steel thickness. There are small areas of more severe localized corrosion. We would regard this amount of steel loss as non-critical, since they are small 2-inch to 3-inch wide areas and will not materially reduce the structural capacity of the wall. In addition, our structural analysis of the wall performed in 2013 showed that this exterior wall had a large margin of reserve strength and could tolerate over 50% loss of steel thickness due to corrosion.

Photo 4 – Corrosion at Joints

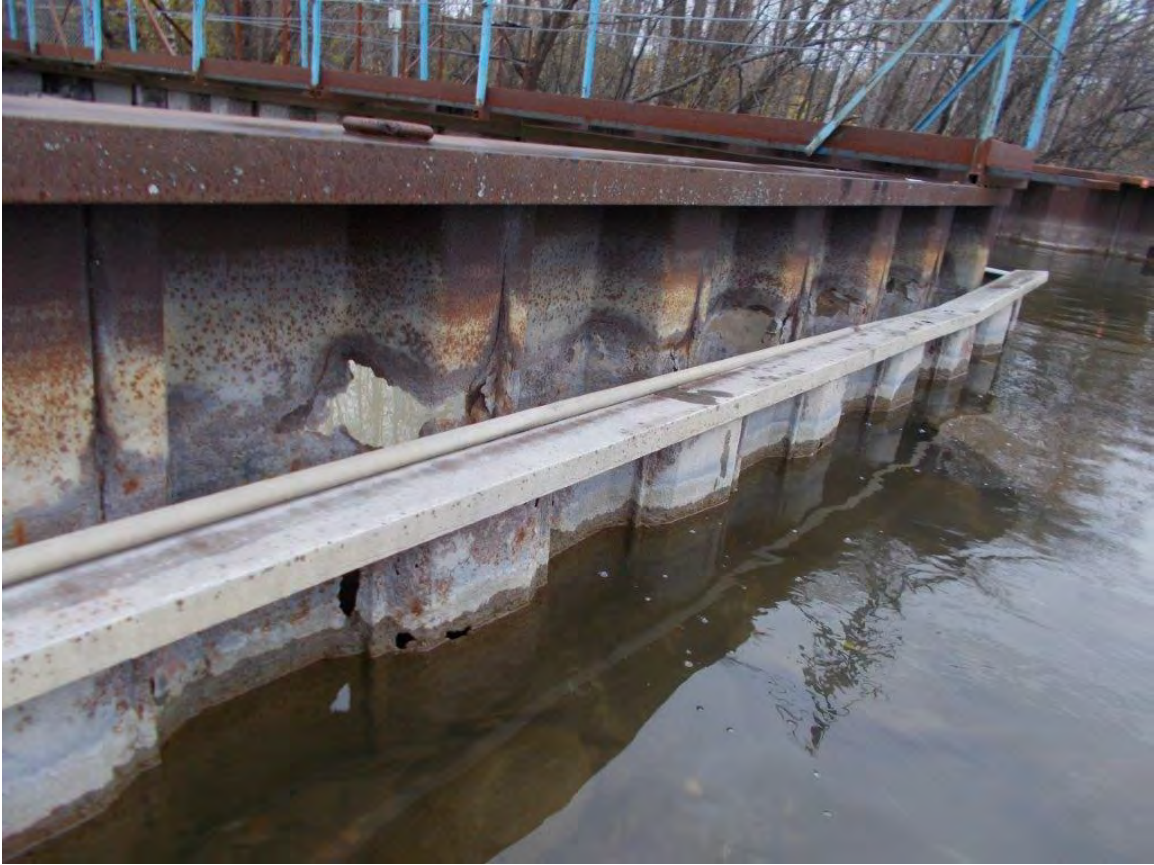
This wall movement is viewed as a minor finding since the movement is small and the interior walls are not critical for containment of the CCR residuals. Although the sheetpile wall is in poor condition, the lateral movement is not visually apparent and there does not appear to be any distress to the walkway mounted on top of the wall. We suggest continued monitoring of the points during subsequent annual inspections. Note that the perimeter sheet pile walls which provide containment do not show any signs of significant movement.

The remaining sheet pile walls which form the internal boundaries between the cells are constructed of a lighter gage sheet pile. It was not possible to examine these walls closely because the cells were full of water and the walls were mostly submerged. The exposed portions appear to be in poor condition (Photo 5 in Appendix C). These internal walls, however, do not affect the structural ability of the pond to contain CCR ash and are only used as baffles to improve the settlement of ash out of the water. Some minor lateral movement was detected to the interior wall between cells 1 and 2. This is viewed as non-critical for the reasons discussed above in section 2.2.

Photo 5 – Interior Walls in Poor Condition

The sheet pile walls which form the north and east boundaries of the holding pond both appear to be stable and have ample structural capacity to contain the impounded water. The south and west boundaries of the holding pond are incised into the ground and pose no threat of failure which would result in a release of CCR materials. The interior sheet pile walls are in poor condition, but are not required for containment integrity of the holding pond. The interior walls can continue to function in this condition as separators between the cells to improve the settlement of solids out of the process water.
