Holding Pond Annual Inspection Report

Marquette Board of Light and Power
Shiras Steam Plant

Project Number: 60445171

January 12, 2017

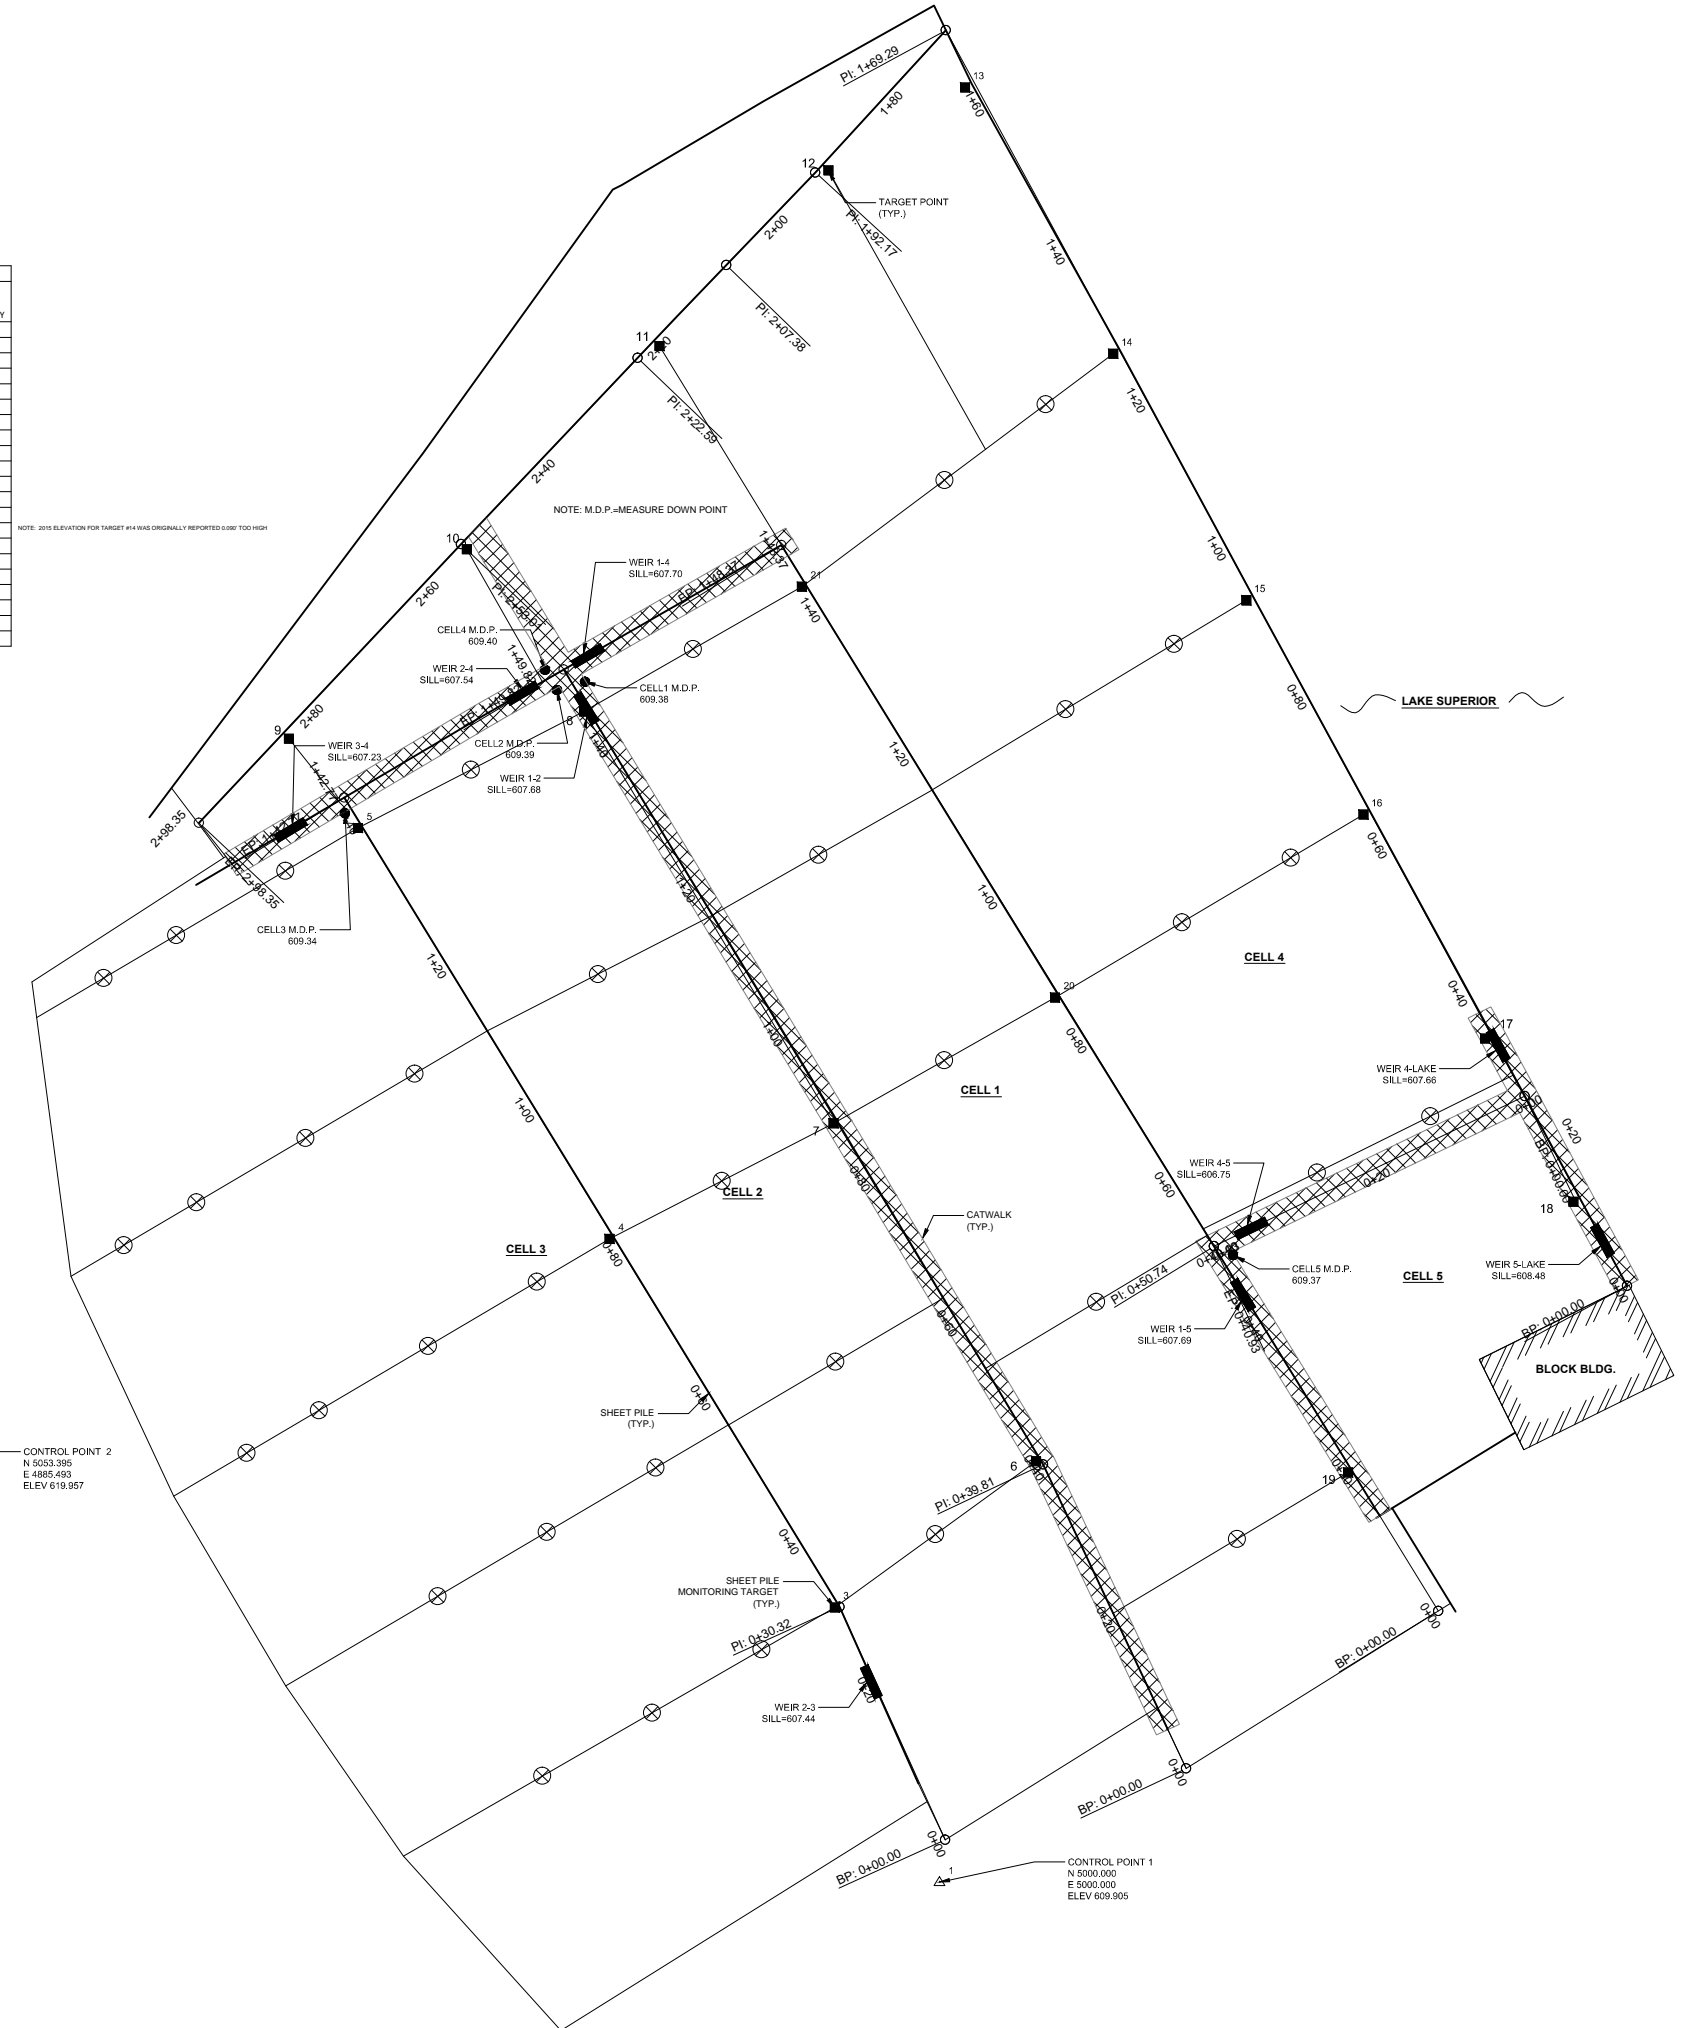
Water levels in the holding pond cells are monitored by measuring down from points of known elevation on the cell access walkways. The location and elevation of each measure down point (M.D.P.) is shown on Drawing 1 in Appendix A. The elevations were determined by an AECOM survey crew during our initial annual inspection on October 15, 2015.

Movement monitoring targets were also installed during the October 15, 2015 survey work. These reflectorized targets were installed near the top of the sheet pile walls at the locations shown on Drawing 1 in Appendix A. Initial coordinates of each target were determined using a total station laser survey instrument set-up over 2 control points which were established on the south and west shores of the pond. The current coordinates of the targets were checked by an AECOM survey crew on November 22, 2016. No significant lateral movement or settlement of the sheet pile walls was detected. This is a good indication that the sheet pile walls are currently stable.

TYPICAL TARGET INSTALLATION

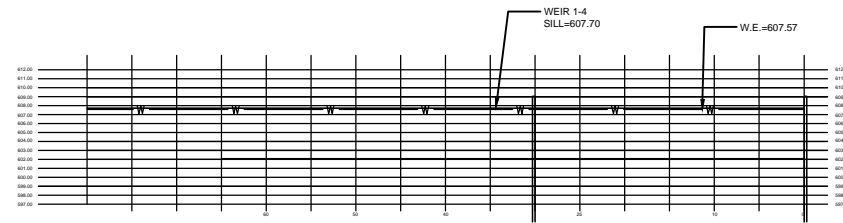
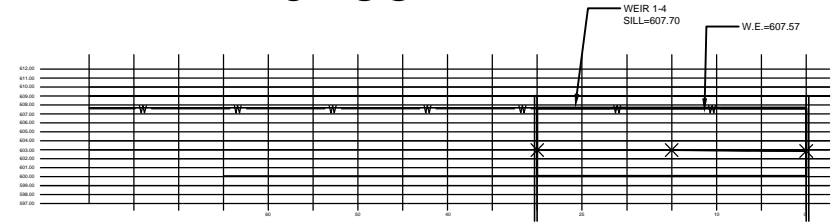
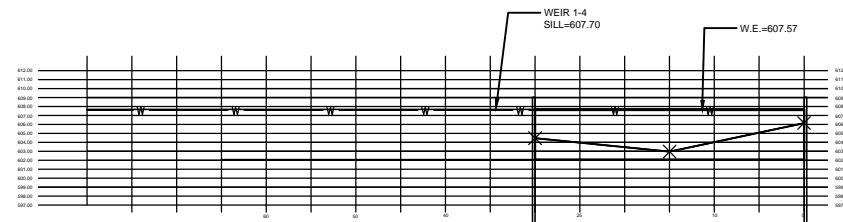
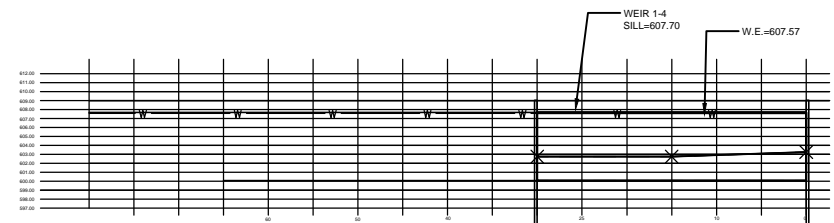
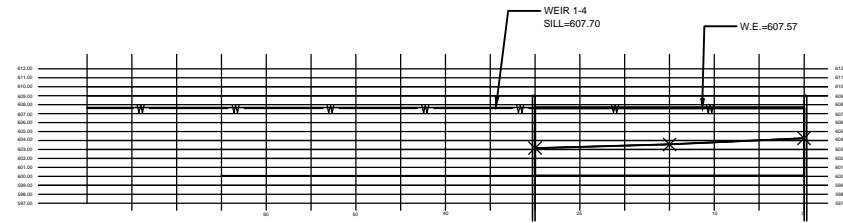
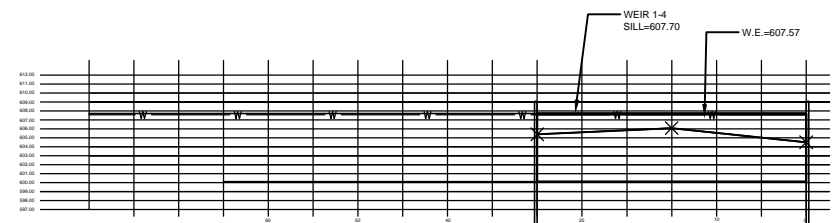
CELL 1

The elevation of the CCR ash deposit surface varies between cells. The ash surface elevation also varies across each cell and cannot be characterized by a single elevation. Water depth elevations to the top of the ash deposits were measured by AECOM from a boat on December 2, 2016. Cross sections of each cell showing the CCR ash bottom profiles were developed using these measurements and are included in Drawings 2 through 6 in Appendix A.

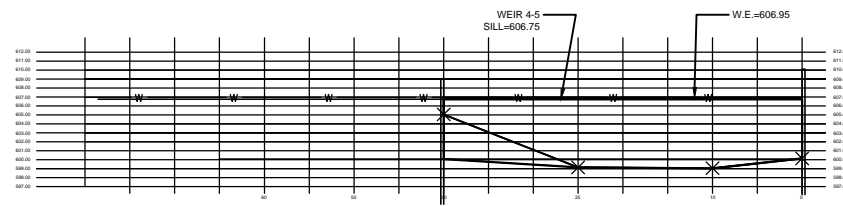
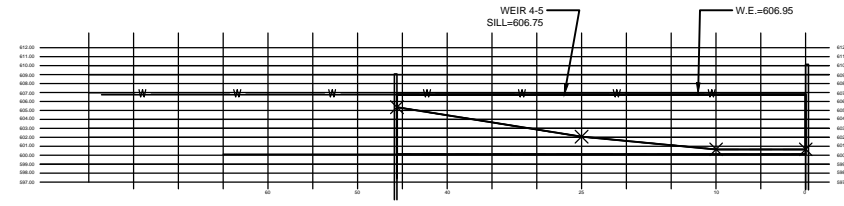
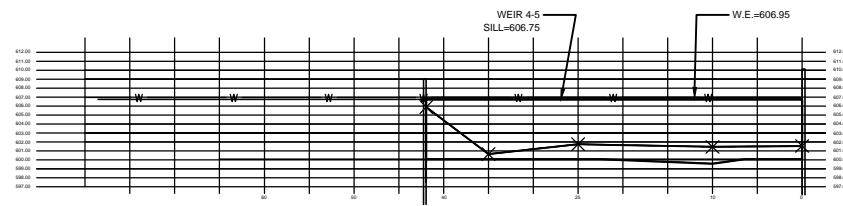
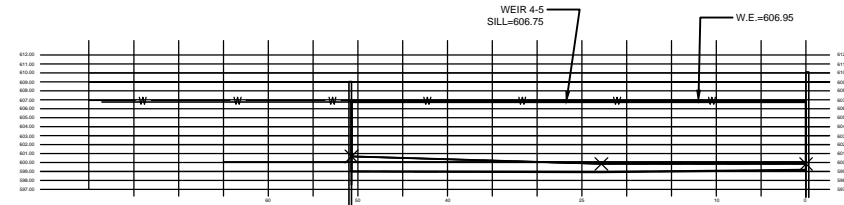
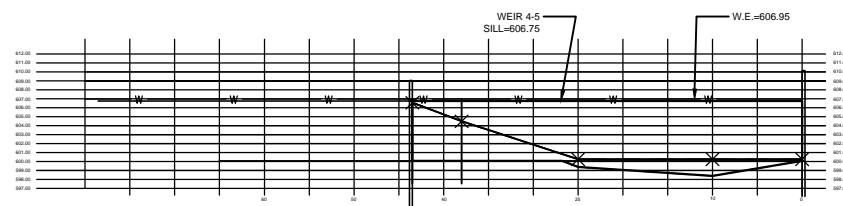
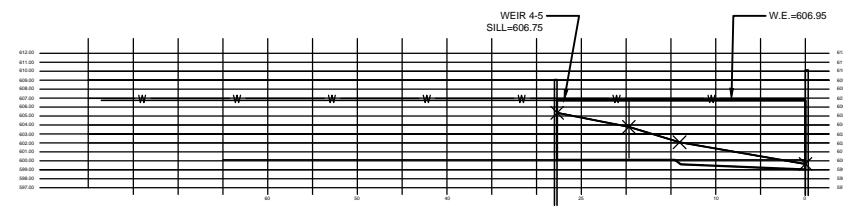
NOTE: CELL 4 BOTTOM HAS BEEN EXCAVATED BELOW 1990 SCA, CINDER POND IMPROVEMENT PROJECT, AT SOME LOCATIONS

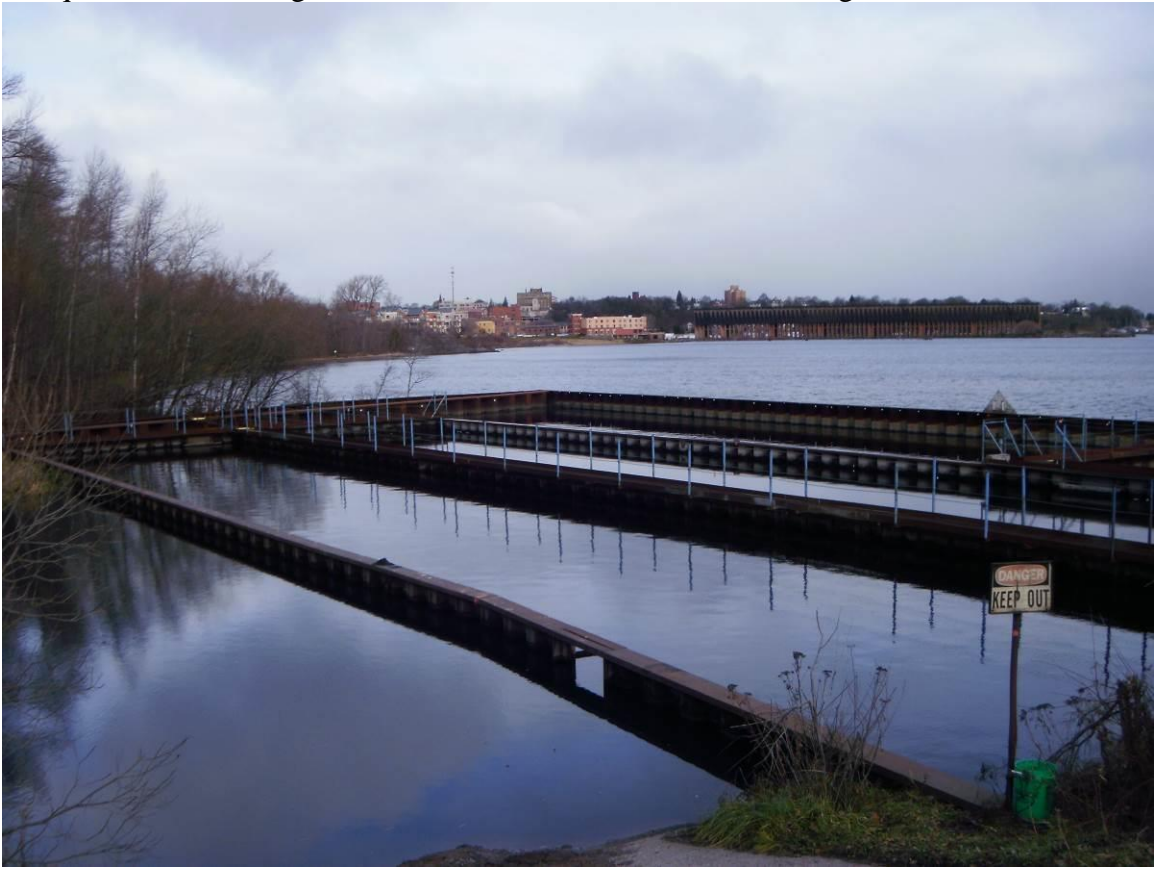
The holding pond is composed of 5 cells which are enclosed by steel sheet pile walls. Its overall configuration is shown in Drawing 1 in Appendix A, and an overall view is shown in Photo 1 in Appendix C. It has been expanded and modified a number of times since constructed. The south and west boundaries of the holding pond are formed by the shoreline of the lake. The east and north boundaries of the holding pond are formed by sheet pile walls which were constructed in 1981. Because of the poor condition of the original north wall, an additional wall was constructed to replace it in 2013. The new wall was placed inside of the original existing north wall, which remains but no longer provides containment (Photo 3 in Appendix C). The walls for the inner cells 1, 2, and 3 were constructed in 1990. There are also some abandoned sheet pile walls in place from previous configurations. The last change to the pond configuration was the addition of the north sheet pile wall in 2013 mentioned above.

Photo1- Holding Pond

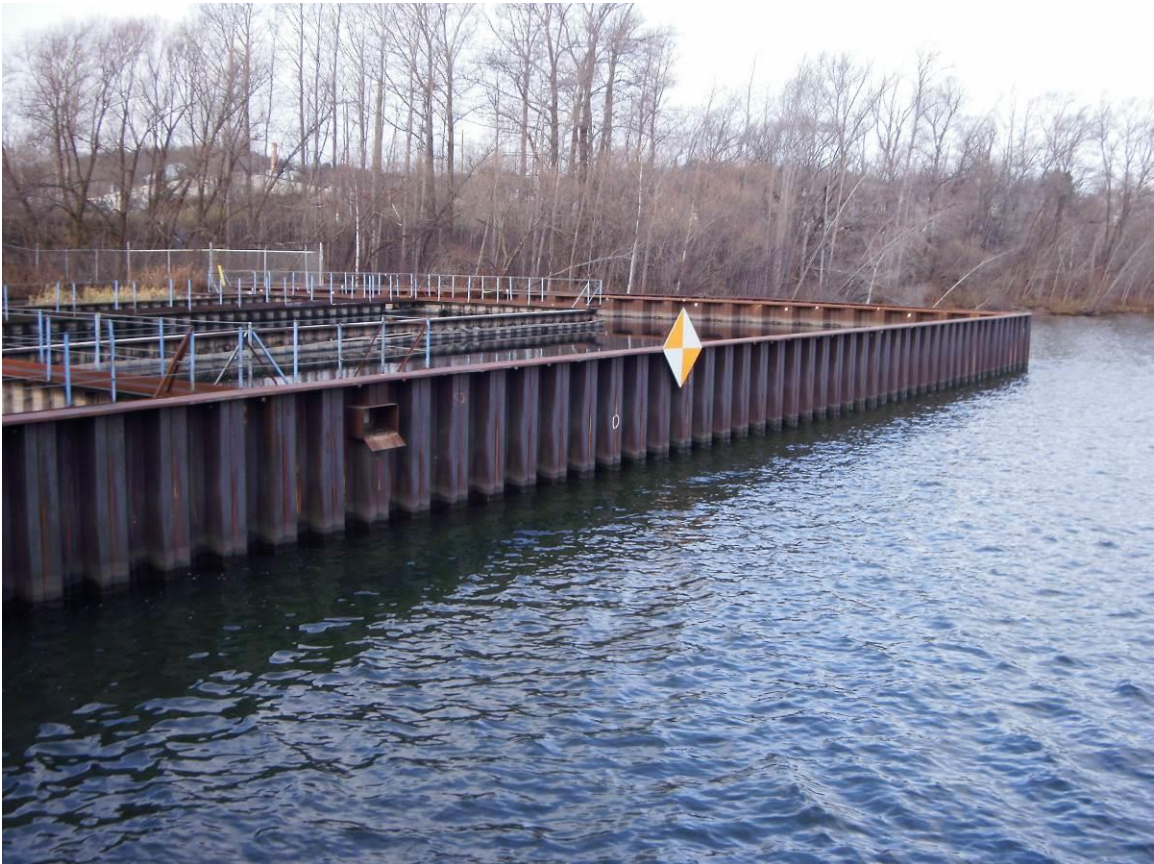
The steel surface on the Lake Superior side of the east sheet pile was bare and the majority of the wall appeared to be in good condition (Photo 2 in Appendix C). The north wall is newer and in very good condition. There were a number of spots of localized corrosion which occurred primarily at the joints between the sheets (Photos 4 and 5 in Appendix C). Most of these had an appearance that suggested there may have been seepage through the joint at one time. No seepage was evident during this evaluation.

Photo 2 – Overall View of East Wall

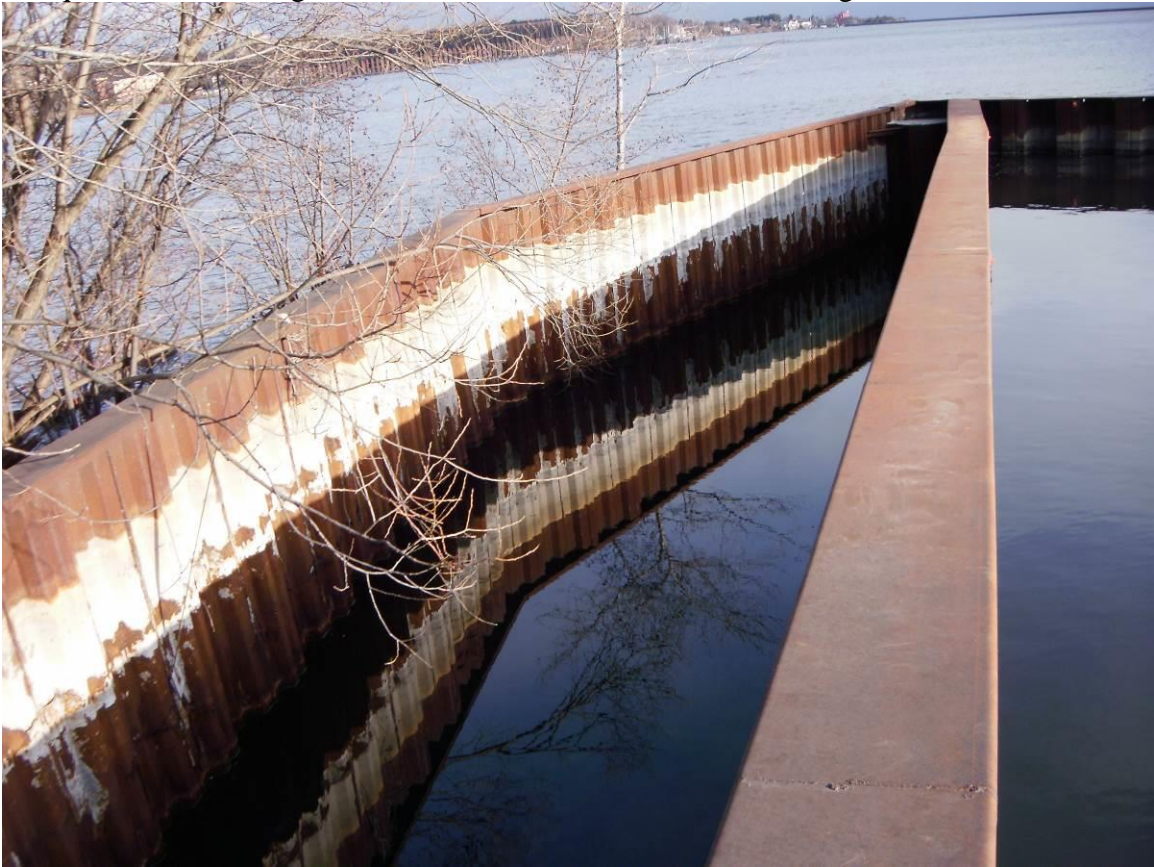
Photo 3 – Recently Constructed North Sheet Pile Wall

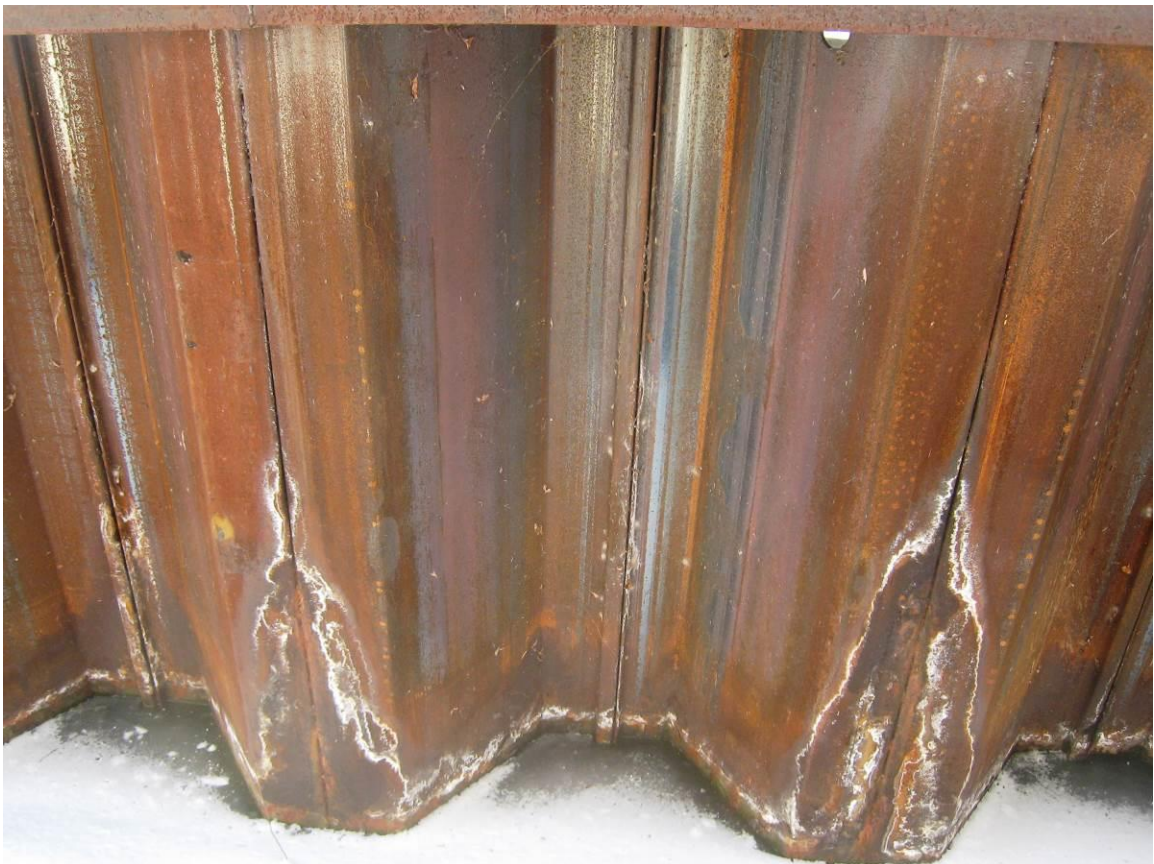
Photo 4 – Corrosion at Joints

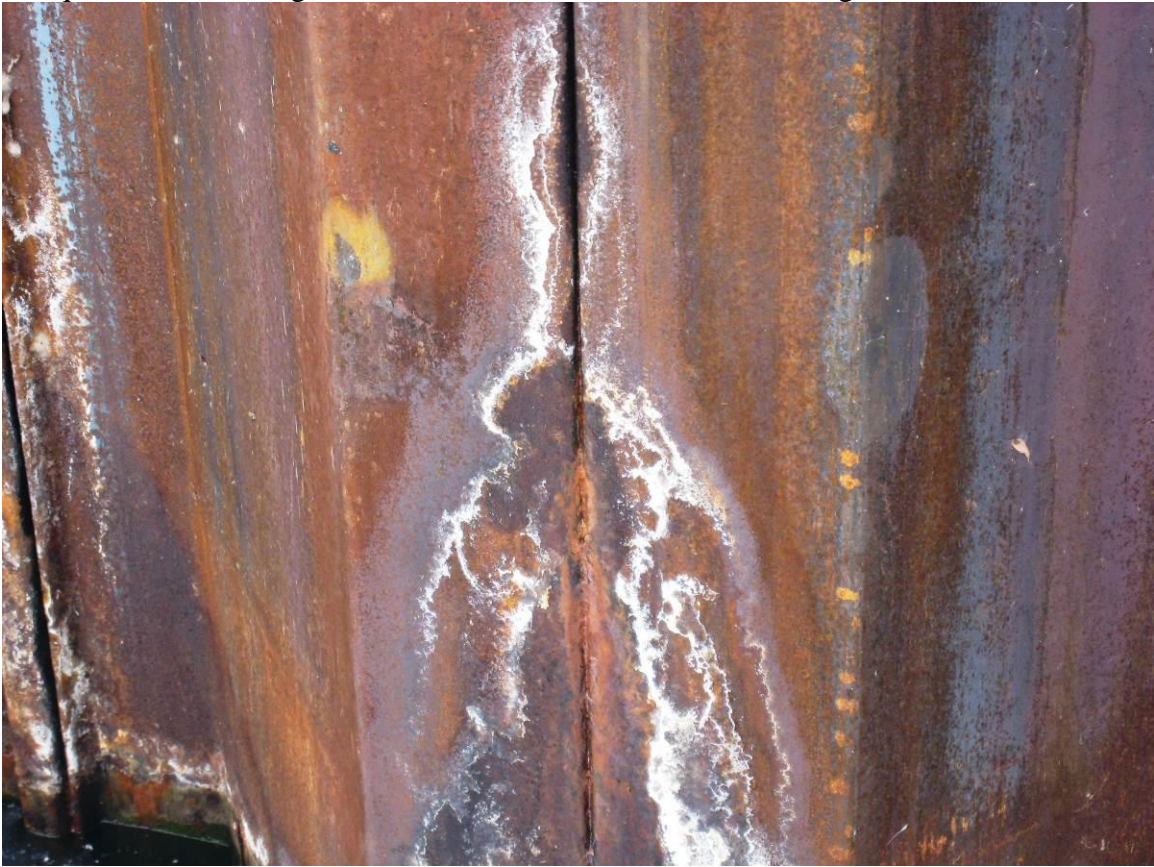
Photo 5 – Spot with Localized Corrosion
