Submitted to:
Marquette Board of Light and Power
Shiras Steam Plant
Marquette, Michigan

Submitted by:
AECOM
Marquette, Michigan
Project No. 60445171
January 15, 2016

Holding Pond Annual Inspection Report

**Marquette Board of Light and Power
Shiras Steam Plant**

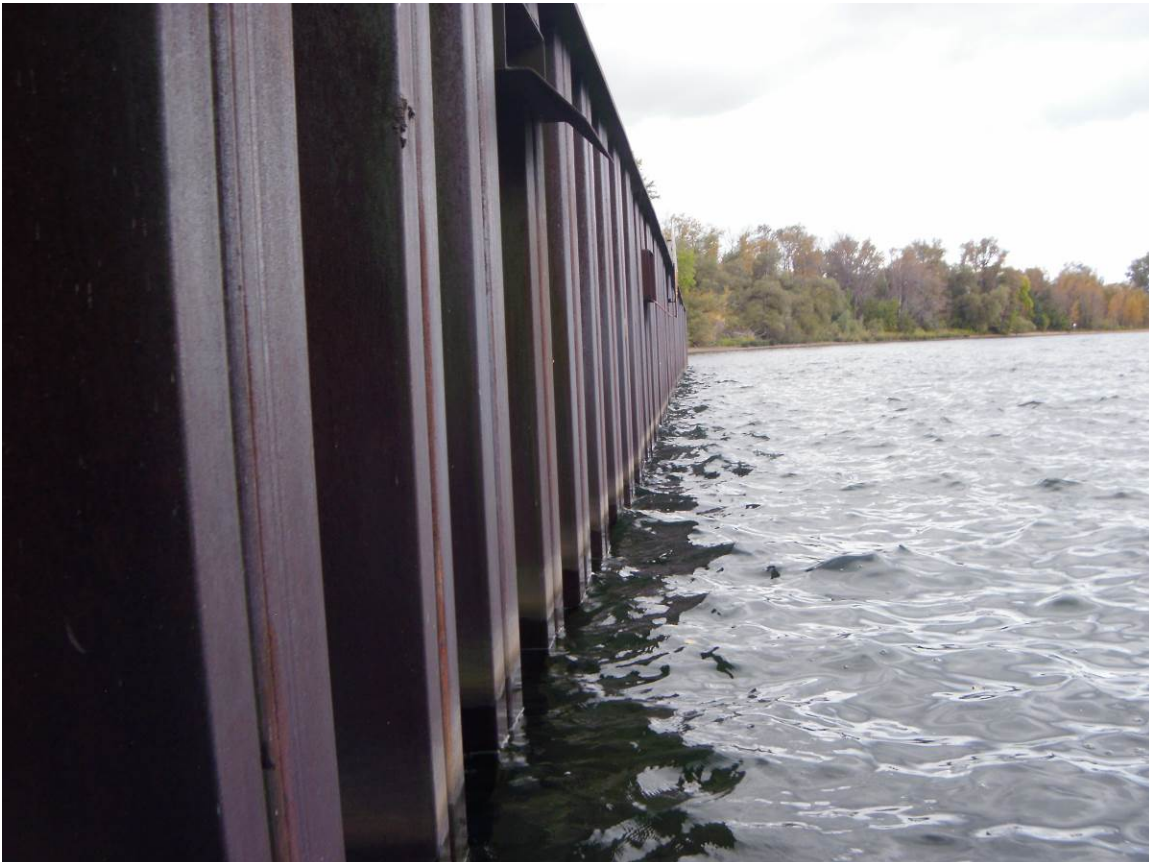
Photo 2 – Overall View of East Wall

The steel surface on the Lake Superior side of the sheet pile was bare and the majority of the wall appeared to be in good condition (Photo 2 in Appendix C). There were a number of spots of localized corrosion which occurred primarily at the joints between the sheets (Photos 4 and 5 in Appendix C). Most of these had an appearance that suggested there may have been seepage through the joint at one time. No seepage was evident during this evaluation.

In order to get an overall view of the condition of the wall, thickness measurements were taken on each 18-inch wide sheet pile section along the 183 feet length of the wall. At least 2 thickness readings were taken on each section with an ultrasonic thickness measuring gage (UT gage). Generally speaking, the readings varied from 0.33-inches to 0.40-inches, indicating little to no loss of the original 3/8-inch steel thickness. There are small areas of more severe localized corrosion (Photo 5 in Appendix C). The minimum remaining thickness was found to be no less than 0.28-inches in these localized spots. We would regard this amount of steel loss as non-critical, since they are small 2-inch to 3-inch wide areas and will not materially reduce the structural capacity of the wall. In addition, our structural analysis of the wall performed in 2013 showed that this exterior wall had a large margin of reserve strength and could tolerate over 50% loss of steel thickness due to corrosion.

The south and west sides of the holding pond are incised into the ground and pose no threat of failure, resulting in a release of CCR materials. The east steel sheet pile wall of the holding pond is currently in fairly good condition and has a good reserve of structural bending capacity. A new heavy gage sheet pile wall was installed in 2013 to replace the deteriorated north wall of the holding pond. The north and east sheet pile wall both appear to be stable and have ample structural capacity to contain the impounded water. The interior sheet pile walls are in poor condition, but are not required for containment integrity of the holding pond. The interior walls can continue in this condition to function as separators between the cells to improve the settlement of solids out of the process water.

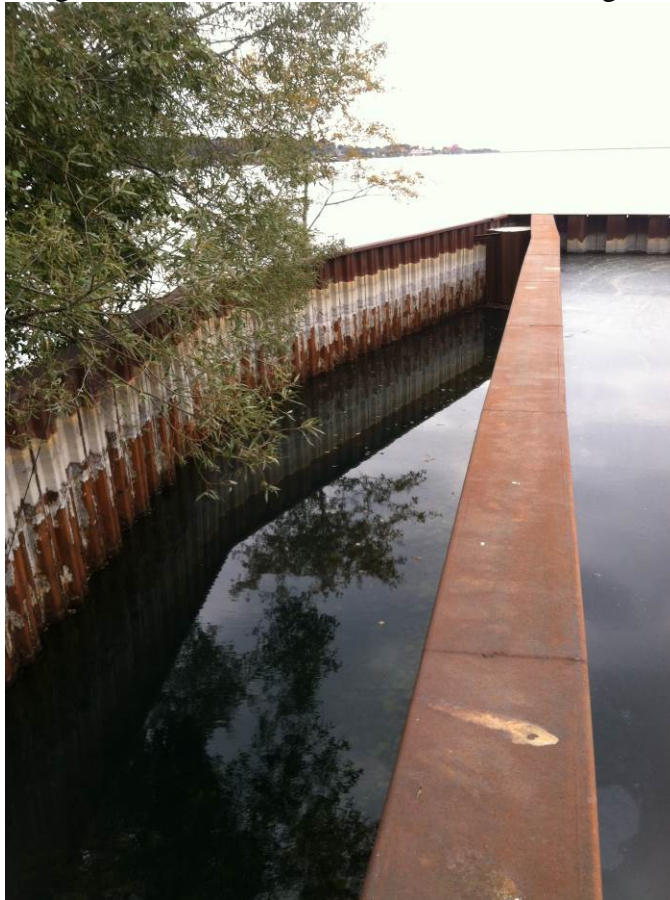
Photo 3 – Recently Constructed North Sheet Pile Wall

The north sheet pile wall was installed in 2013 and is in excellent condition. It is constructed of heavy gage sheet pile similar in size and structural capacity to the sheet pile used for the east wall.

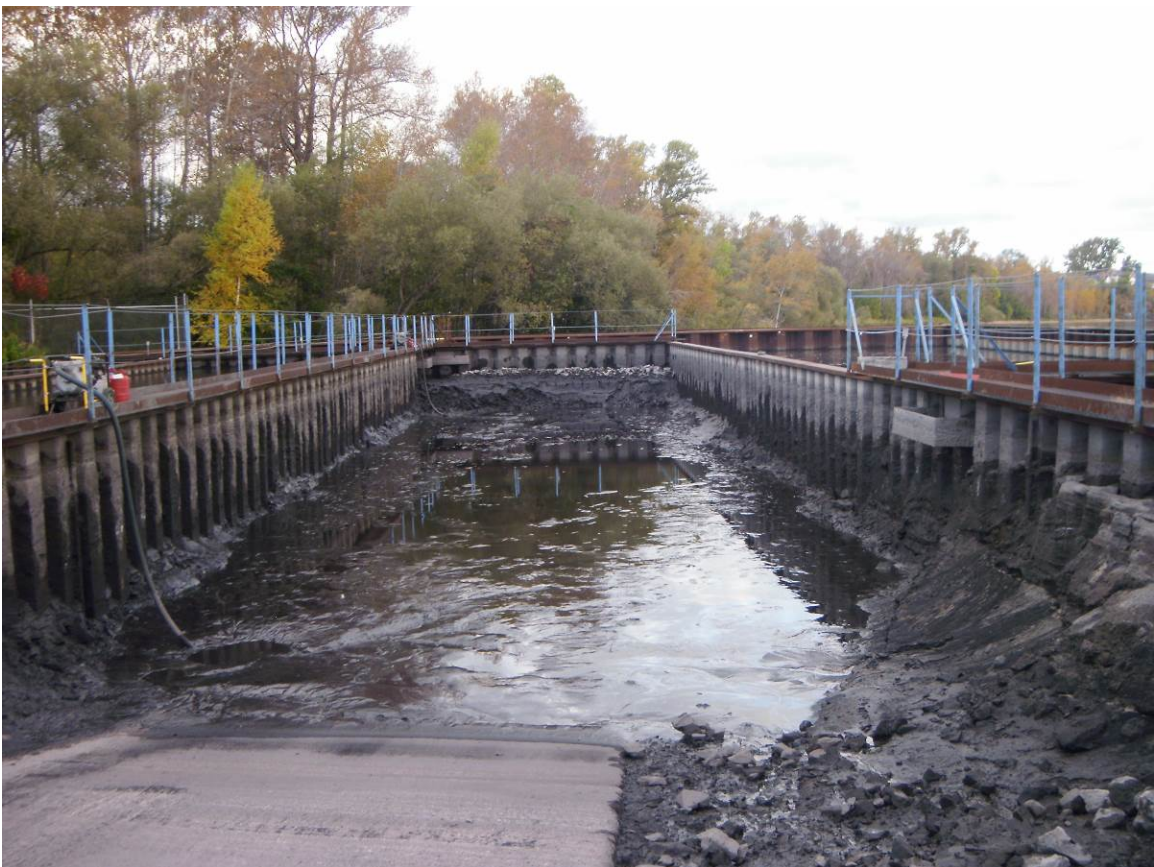
Photo 6 – Dewatered Cell 1

There are several ramps on the south shore of the impoundment which allow loaders to enter the cells to remove solids which have settled out of the impounded water. The cells are periodically drained to allow this cleanout operation. The residuals are primarily composed of bottom ash but also contain components from other waste streams including coal pile runoff and storm water. The residuals are removed to an off-site landfill.
